# ***Side Scan Sonar***

## ***– Hazard Detection & Debris Clearance***

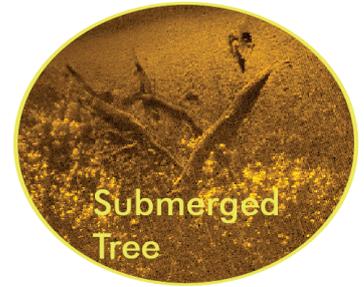
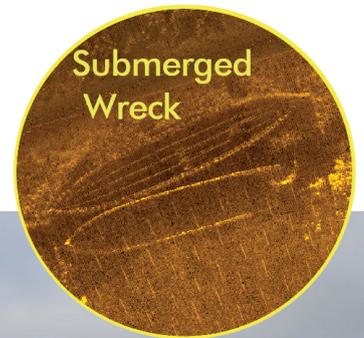
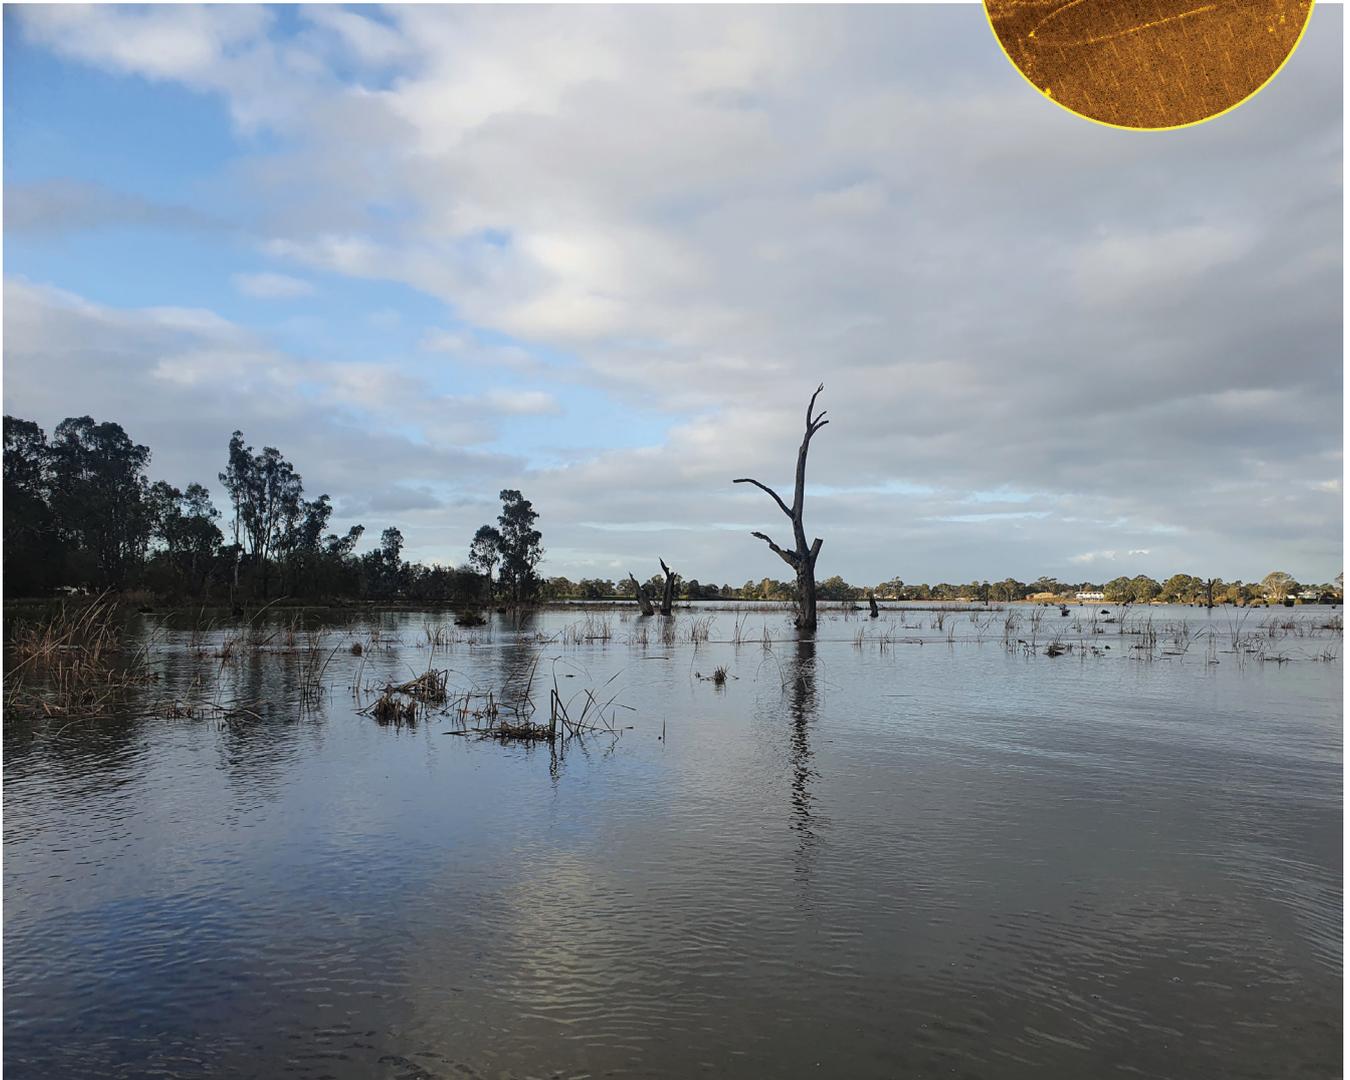
In the shallow water environment, we were able to gain high resolution geo-referenced imagery, across a 25m swath with the side scan sonar unit. Running 20m survey lines we had sufficient overlap with the side scan imagery that we were able to provide the client with a geo-referenced side scan mosaic. This geo-referenced image provides a clear understanding of the hazards and debris that were located on the lakebed. The imagery can offer the location and size of debris beneath the water allowing the council to give a safe route for which recreational boaters and water skiers can use.

Side scan sonars are often operated as towfish in deep water environments, however the lack of water depth meant it was best to attach the side scan sonar to over the side mount or our single beam echo sounder. The Starfish 990f is a high-resolution side scan sonar unit that can be used for extreme image definition and target detection. It operates at a 1MHz CHIRP transmission with an extremely narrow horizontal acoustic beam to provide sharp and defined side scan images.

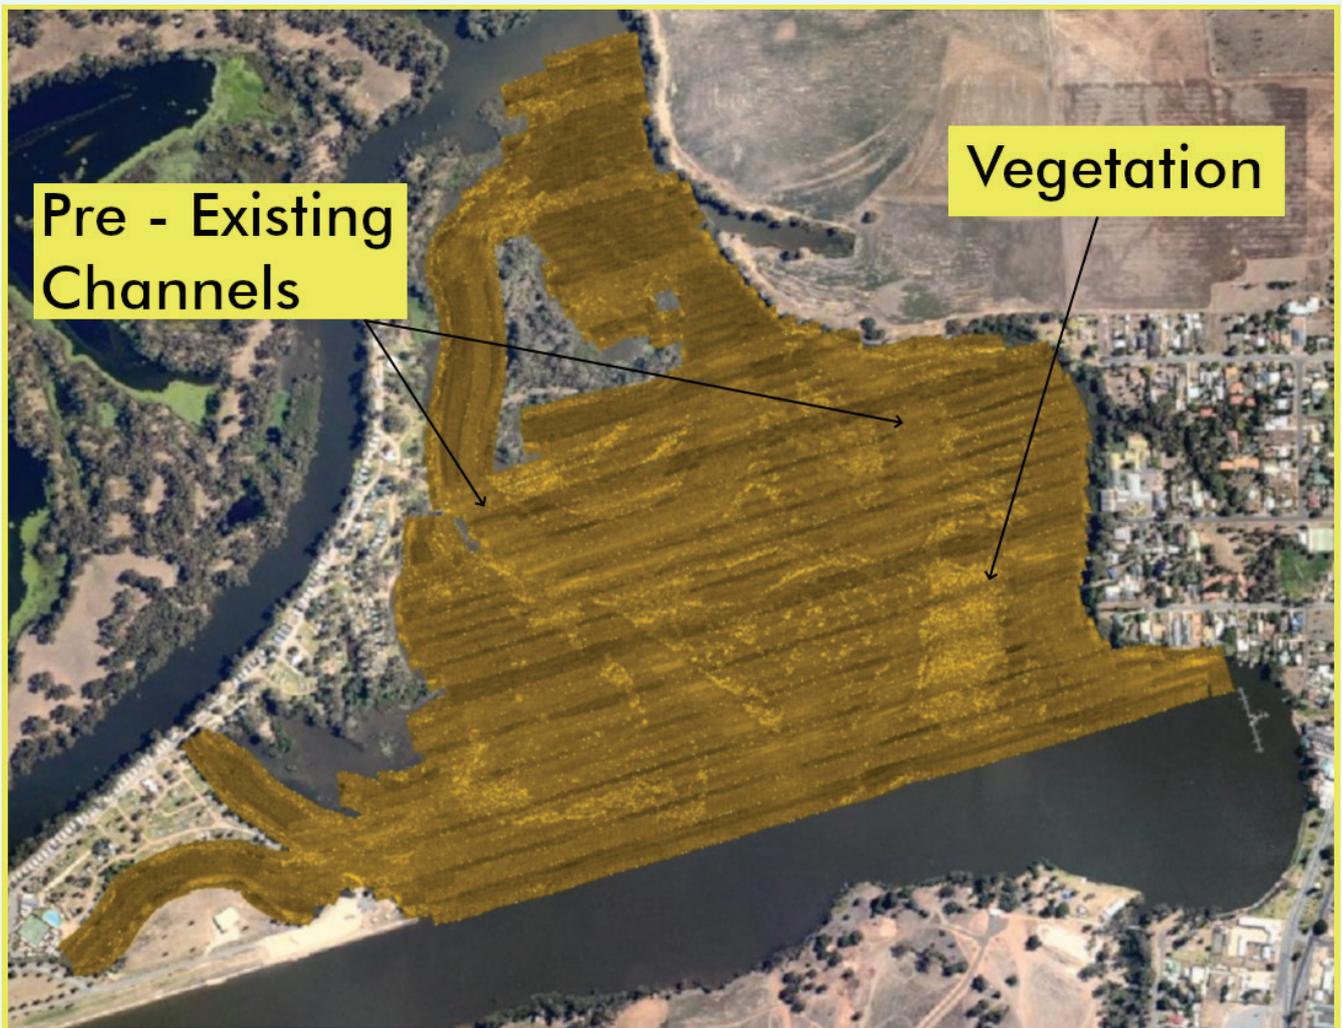
The single beam echo sounder captured depth data that was used to provide general bathymetric contours for the lake extents. It was able to pick up previous river channels that were present in the lake that could be used for potential boating access. The campaign provided detailed bathymetric and side scan sonar data that would allow the council to make informed decisions about the management and development of its waterways. The side scan sonar imagery should help the council determine where access to the lake can be safely navigated and which areas needed to be restricted from recreational boating activities.
